DEPARTMENT OF TRANSPORTATION

Contract #: 04-0120F4Cty: SF/ALA Rte: 80 PM: 13.2/13.9File #: 69.28**WELDING INSPECTION REPORT****Resident Engineer:**Siegenthaler, Peter**Address:** 333 Burma Road**City:** Oakland, CA 94607**Report No:** WIR-026036**Date Inspected:** 20-Jul-2011**Project Name:** SAS Superstructure**OSM Arrival Time:** 700**Prime Contractor:** American Bridge/Fluor Enterprises, a JV**OSM Departure Time:** 1900**Contractor:** Zhenhua Port Machinery Company, Ltd (ZPMC), Changxing Island **Location:** Shanghai, China

Orthotropic Box Girder (OBG) at Trial Assembly Areas

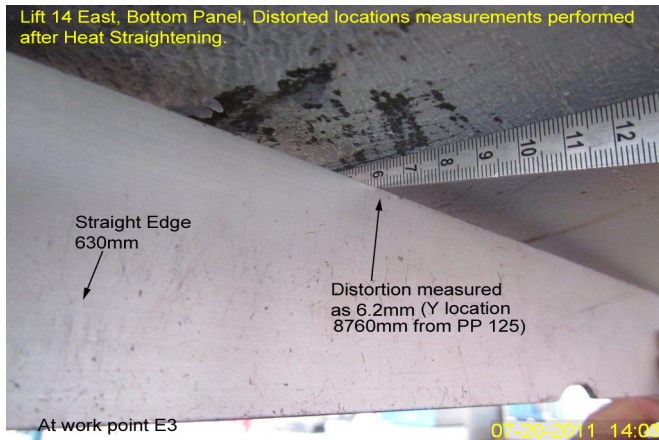
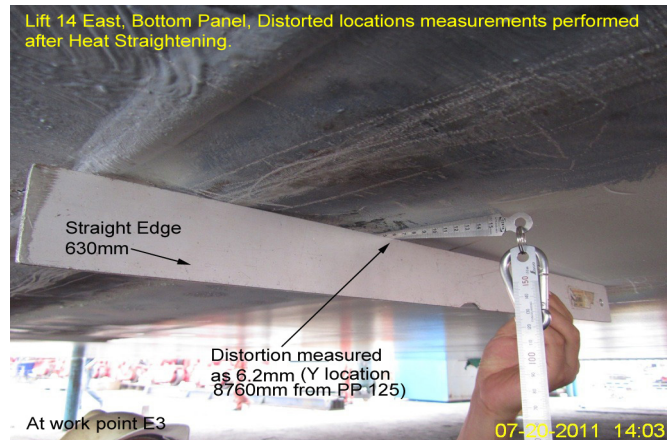
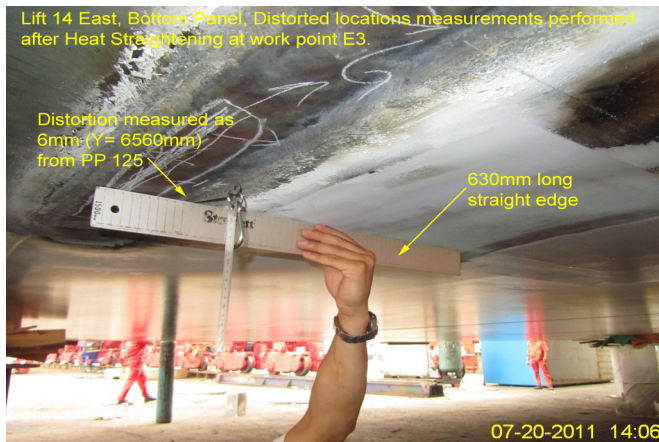
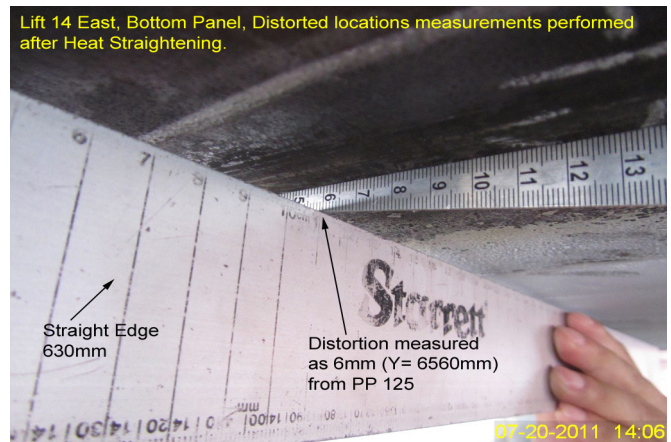
Segment 14 East (Bottom Panel)

This QA Inspector was requested by ZPMC QC and ABF QA to perform the inspection for distorted Bottom Panel at work point E3 (Bike Path side). Incident Report was generated for the distorted Bottom Panel on July 13, 2011, Viz., 04-0120F4_TL-15_B278_07-13-2011_14East_Bottom Panel_Distorted_WP_E3.

The inspection was performed and observed 6mm distortion at Y= location 6560mm and 6.2mm distortion at Y=location 8760mm.

Please reference the pictures for more comprehensive details.

The measurements were conveyed to the Lead Inspector and Engineer for review and disposition.
